## Affordable thermal imagers detect energy waste in buildings

### Application Note

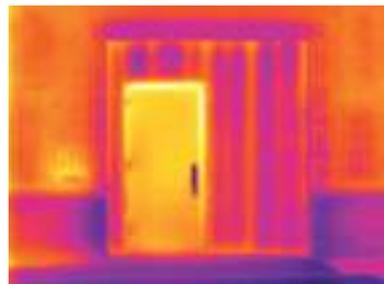
Figure 1: Energy loss via the door of a building.

The easiest and quickest method of detecting energy waste in buildings (Figure 1) is infrared thermography. This is a non-destructive, non-contact method of locating faults by measuring the infrared radiation emitted by surfaces. Viewing a thermal image immediately points users to anomalies which could indicate potential faults. It identifies a whole range of issues including missing or damaged insulation, air leakage, moisture intrusion in roofs and walls, actual and potential mold areas, thermal bridges and water leakages.

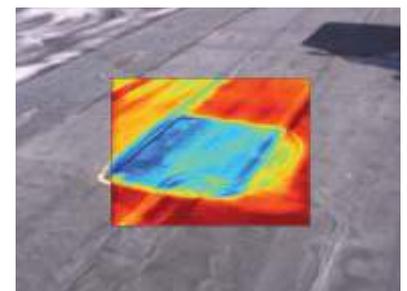
Figure 2: Wet insulation in flat roofs can cause rotting unless detected and corrected.

In roofing surveys, the imagers detect wet insulation under the roof membrane in flat roof systems, allowing wet portions of the roofing structure to be repaired or replaced before the entire roof is damaged (Figure 2).

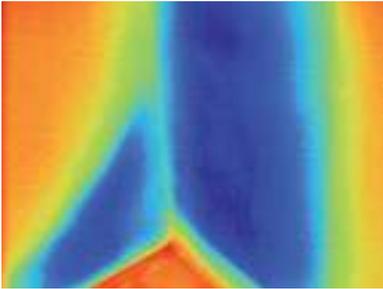
Figure 3: Fluke's TiR Series finds hidden cold spots and moisture behind walls and other surfaces.

In restoration projects, moisture can be detected despite being concealed behind walls (Figure 3), ceilings or covered floors. That helps control mold by finding sources of moisture that would otherwise go undetected.

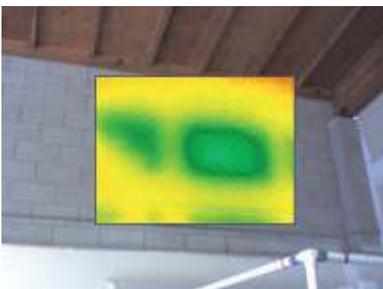
Figure 4: IR-Fusion helps pinpoint problems in buildings by combining infrared and visible images.

All users need to do is point the imager, focus it, and capture. And like most Fluke thermal imagers they feature IR-Fusion®. Although infrared imaging clearly highlights temperature differences, pure infrared images can be difficult to interpret. The affected areas can be hard to pinpoint – a cold patch somewhere on a wall (Figure 4), or a wet patch in a large roof. Fluke's IR-Fusion® technology solves the problem by superimposing the infrared image on a detailed

visible image, allowing users to clearly identify critical points within the thermal image.

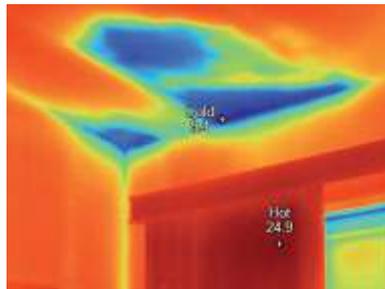
Figure 5: Thermal resolution for the TiR Series is as low as 0.07 ° Celsius. This gives the clearest possible view of possible problem areas.

Their optimized thermal sensitivity (NETD = Noise Equivalent Temperature Difference) identifies the smallest temperature differences. This is particularly important in building diagnostics, where a small difference can indicate a potentially large problem (Figure 5).
